A Unique case of knee Reconstruction

By Dr. Wilfred D'Sa, MS Orthopaedics, Fellowship in Limb Reconstruction and Lengthening.

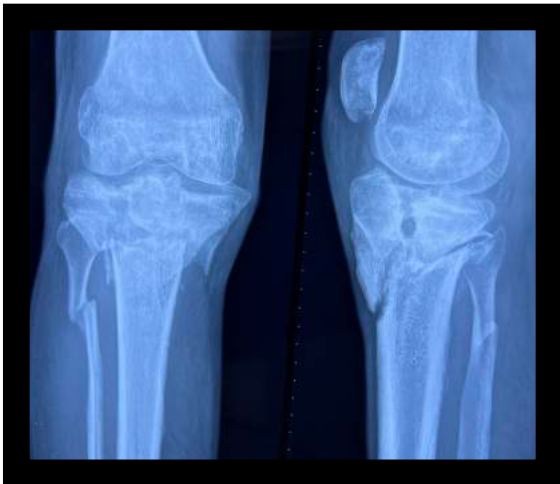
When we investigated him, his initial x ray revealed an incongruently reduced knee joint with malalignment of the leg bone. His knee joint was highly unstable and moved with the slightest force applied.

Fig 1: Xray showing the malunited fracture of the proximal tibia and fibula bone.

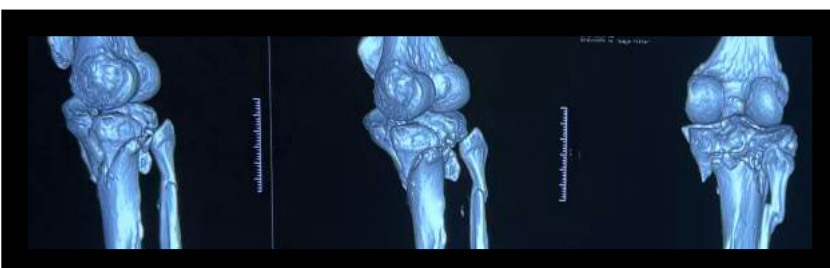
We decided to investigate further, so we got a three dimensional high resolution CT scan done, which revealed the details of his problem.

Fig 2: 3D CT scan showing the complexity of the problem

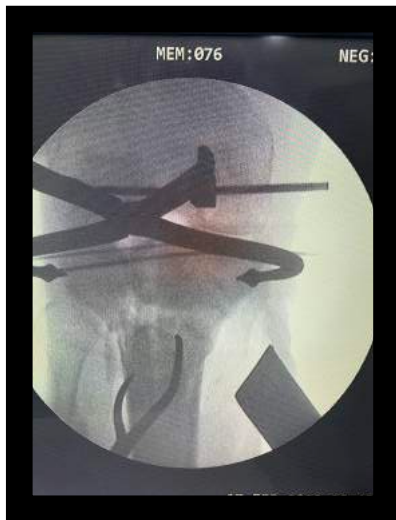
Fig 3: An intra operative image showing how the fracture is being reconstructed with tools and wires.

The procedure involved an extensive incision, meticulous dissection and calculative osteotomies. We had to technically recreate the original fracture and put everything in place from scratch. We had the advantage of a tourniquet and an electric cautery which limited blood loss and the advantage of a C arm with live imaging, so we could visualise our steps so as to achieve precise reconstruction of the joint.

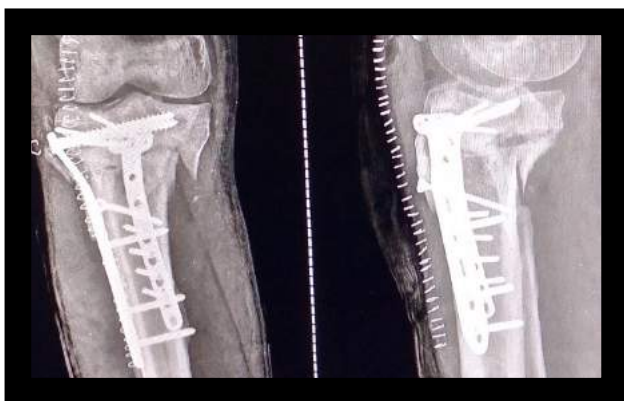
Fig 4: Post operative XRAY showing the congruity of the the knee joint in both angles.

The reconstructed bone was finally held in place with two titanium plates and locking screws. After confirming the knee function and stability, the incision was repaired from the bone, muscle upto the skin.

The Post operative result was very satisfying and the patient had a return of his function within two weeks.
